STOPPING A ROCKET

Installing Wilwood Engineering Brakes on a 2007 GT500 Mustang

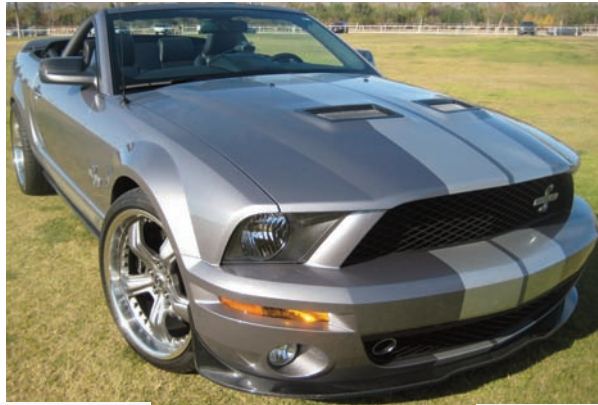
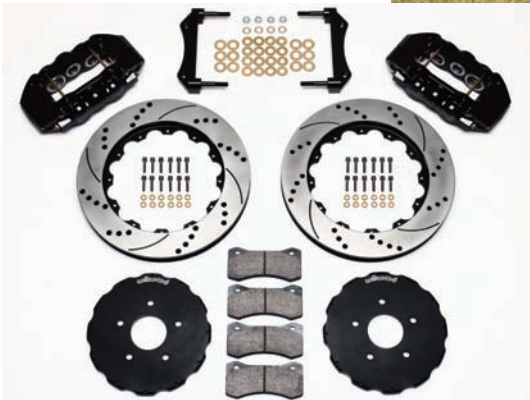
The Wilwood part number 140-10830 disc brake kit features the W6A calipers, caliper brackets, drilled and slotted 14-inch diameter rotors with aluminum hats, BP-10 Smart Pads and all of the hardware required to finish the installation.

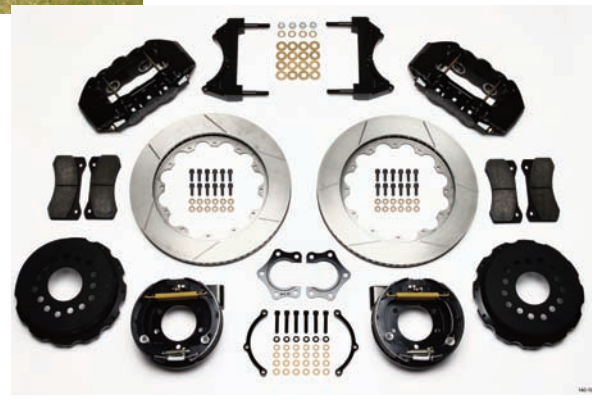
The Wilwood part number 140-10950 internal brake rear brake kit features W4AR calipers, caliper brackets, the internal brake assembly, 14-inch diameter drilled and slotted rotors, aluminum hats, BP-10 Smart Pads and all of the hardware required to finish the installation
